*Opportune Landing Site Program*

## **GIS-based OLS Suitability Assessment**

April 2008

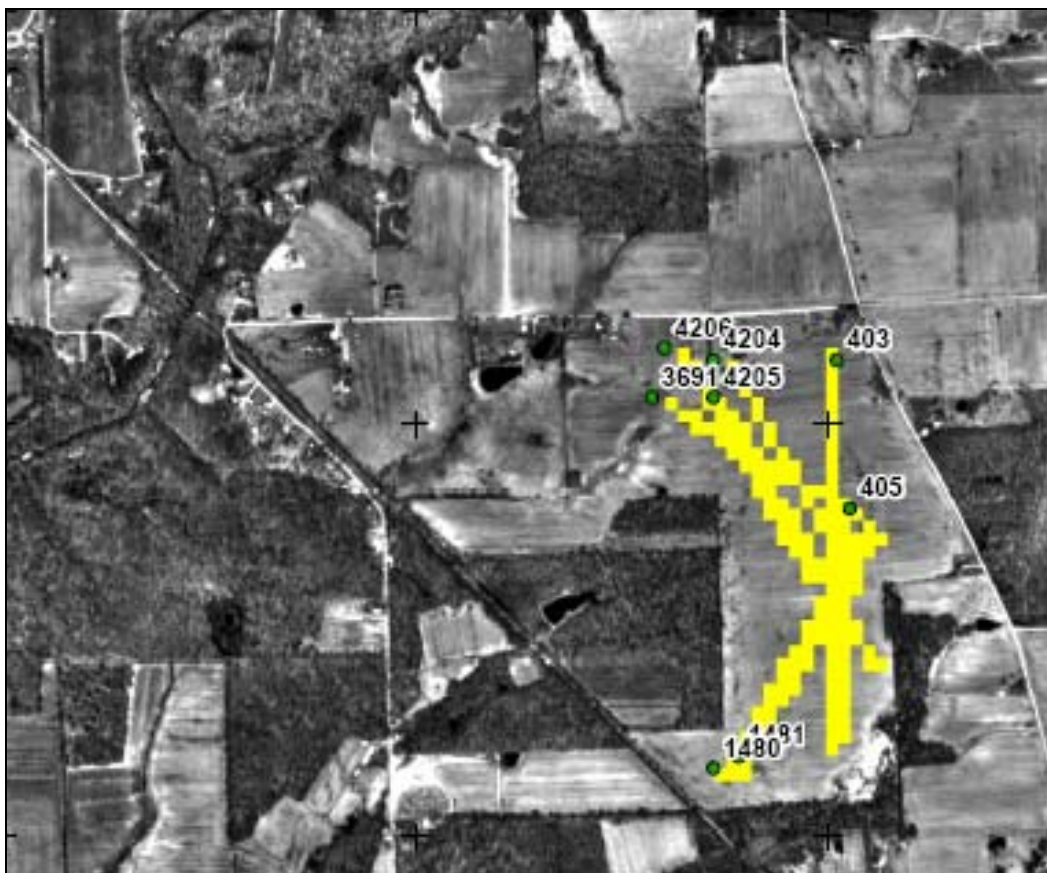
Figure 1. Predicted OLSs mapped against orthophotoquadrangles for field checking in southern Indiana, 17 March 2005. Yellow pixels denote OLS locations, green dots indicate the ends of OLSs, and numbers identify each OLS. Overlapping numbers are artifacts of the OLS software. Each pixel in an OLS is 30 m square on the Earth's surface.

ERDC formally evaluated OLS quality by selecting four field sites for intensive field work. Field sites were selected by conducting reconnaissance trips in southern Indiana, Ft. Bliss, and El Centro NAF. Potential field sites were located in each area by using the OLS software to predict all prospective OLSs with a specified length, width, and suite of headings (Fig. 1) (Affleck et al. 2008a, 2008b, Barna et al. 2008). A field team then visited the areas and viewed as many OLSs as reasonably possible by drive-by inspection (Fig. 2).

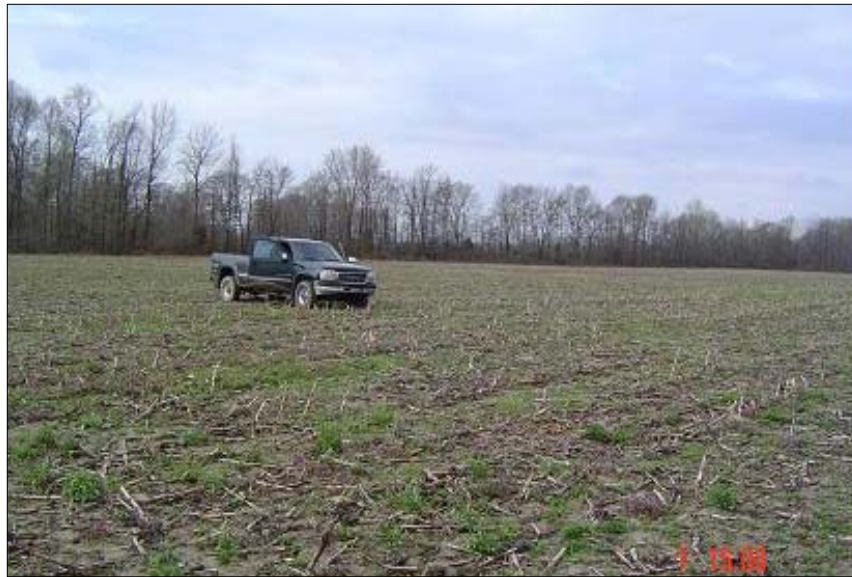
Figure 2. Reconnaissance of an OLS on Ford Farm in southeastern Indiana.

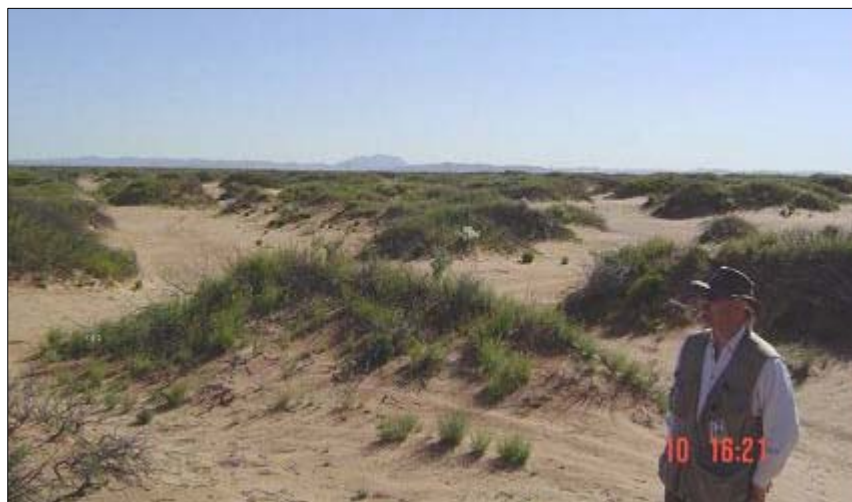
Figure 3. OLS at Ft. Bliss partially walked and found to be unacceptable due to mesquite dunes.

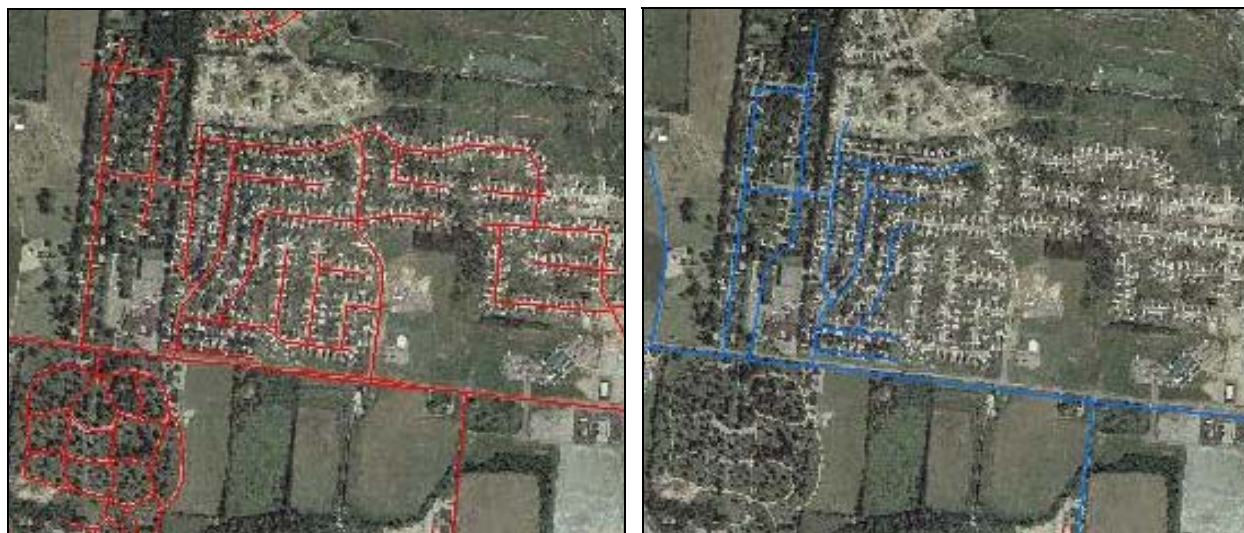
Figure 6. Tele Atlas primary and secondary road vectors, in red, overlying a DOQ (left) and USGS DLG roads, in blue, overlying the same DOQ (right). Secondary roads are not as completely represented on the USGS product.

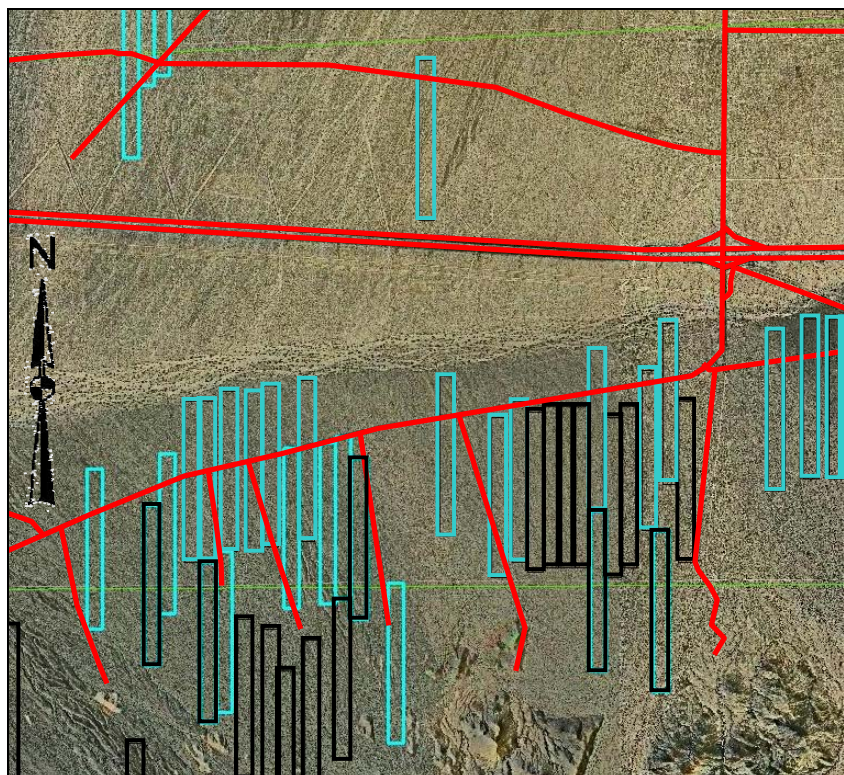
Figure 8. Example in southern California of the intersection of roads (red lines) with OLSs (blue rectangles). OLSs not intersected by roads are outlined in black. The OLSs are 930 m long and 90 m wide.

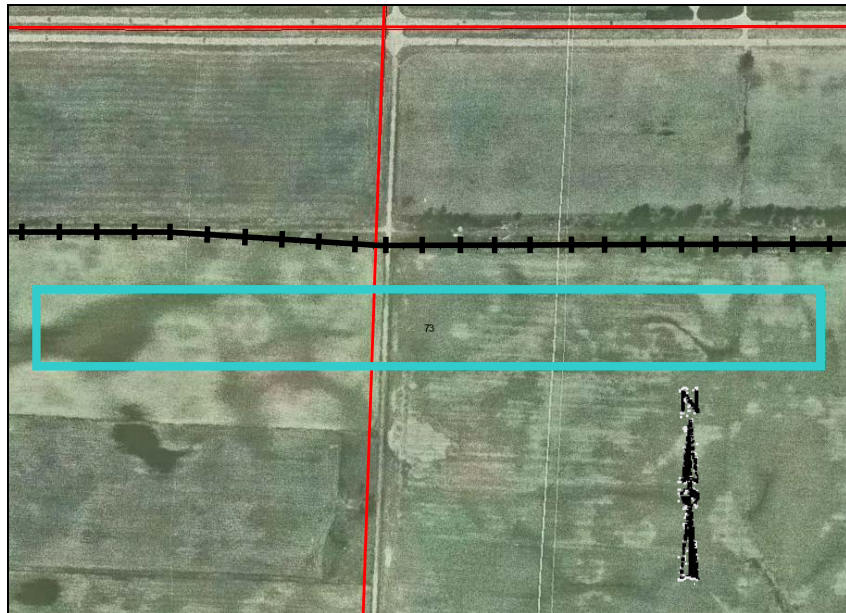
Figure 10. Intersection of a road (red lines) with an OLS (light blue rectangle) in southern Indiana. The hatched black line is a railroad. The OLS is 930 m long and 90 m wide.

Figure 10 illustrates an OLS in southern Indiana with a road intersection nearly in its center. Though there are misalignments between the vector roads and the roads visible in the DOQ, the OLS-road intersection is still significant.

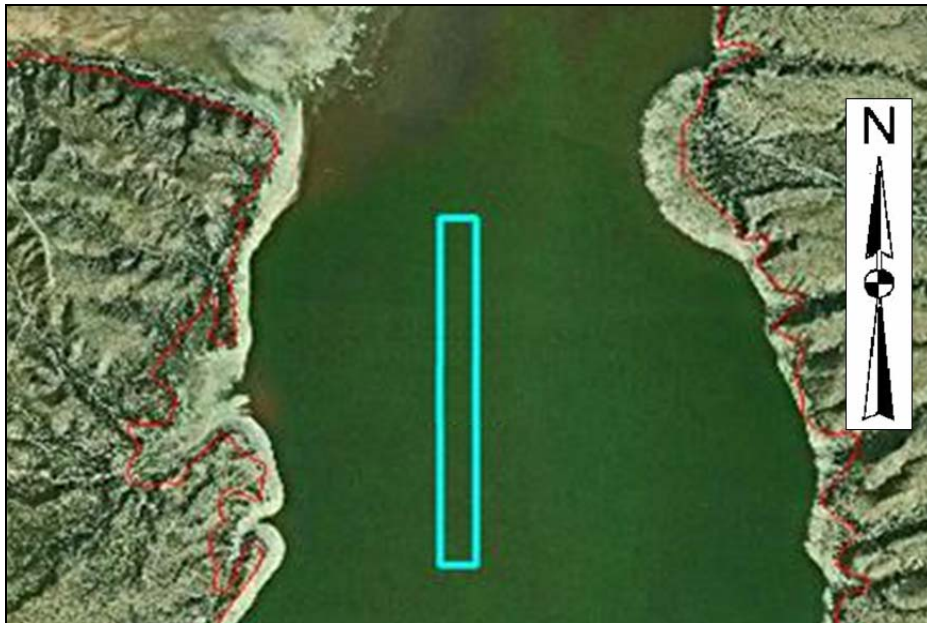
Figure 15. OLS in water in the DOQ image.

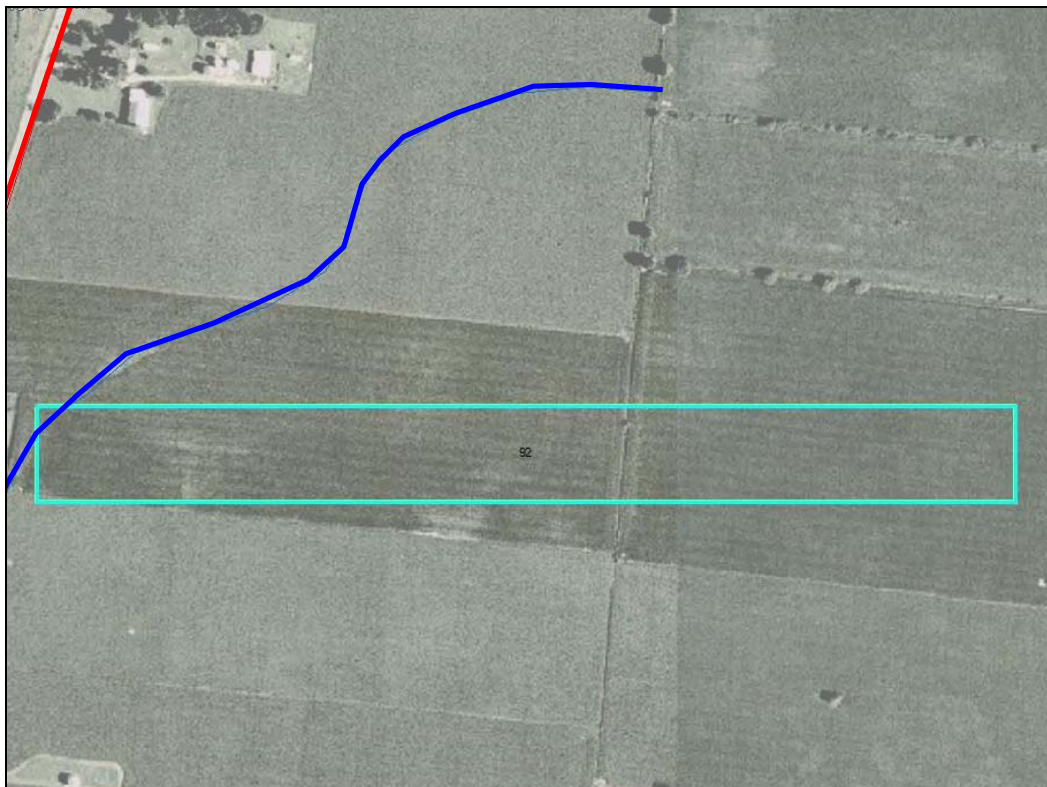
Figure 25. OLS in Indiana crossed by an undigitized agricultural road. The OLS is 930-m long and 90-m wide.

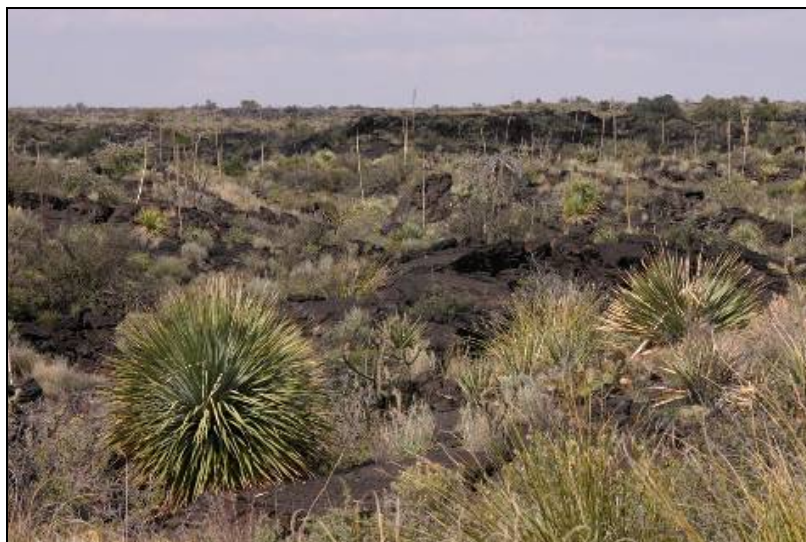
Figure 44. Surface of the Carrizozo Malpais Lava Flow, which is unsuitable for aircraft ground operations.

The OLS-MS software also located 31 of the visually inspected OLSs on the Carrizozo Malpais Lava Flow, a surface of broken lava with large cracks and relief of several meters (Fig. 43). Though appearing uniform at the resolution of Landsat, the surface is unsuitable for aircraft ground operations (Fig. 44). This is an obstacle that a vector database would not have located, though a digital surface geologic map may have provided an indication of conditions.
